DEPARTMENT OF TRANSPORTATION

Federal Aviation Administration

Airworthiness Directives; Agusta S.p.A. Helicopters

ACTION: Notice of proposed rulemaking (NPRM).

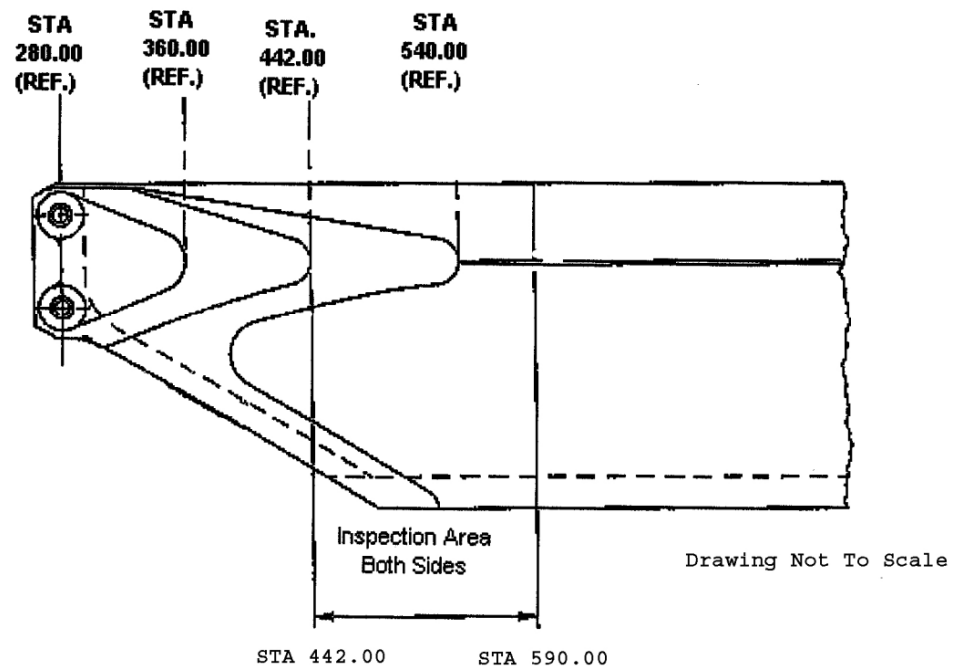
This AD defines the unsafe condition as a fatigue crack in a T/R blade. This condition could result in failure of the T/R blade and subsequent loss of control of the helicopter.

(1) Before each start of the helicopter engines, visually check both sides of each T/R blade for a crack in the inspection area depicted in Figure 1 to paragraph (f) of this AD. This action may be performed by the owner/operator (pilot) holding at least a private pilot certificate, and must be entered into the aircraft records showing compliance with this AD in accordance with 14 CFR 43.9 (a)(1)-(4) and 14 CFR 91.417(a)(2)(v). The record must be maintained as required by 14 CFR 91.173, 121.380, or 135.439.

(5) If there is a crack in a T/R blade, before further flight, replace the cracked T/R blade.
